# Washington State Ferries Keystone Citizen Advisory Group

## *Information on Safety and Operational Issues from the Keystone Terminal Relocation Feasibility Study, August 2003<sup>1</sup>*

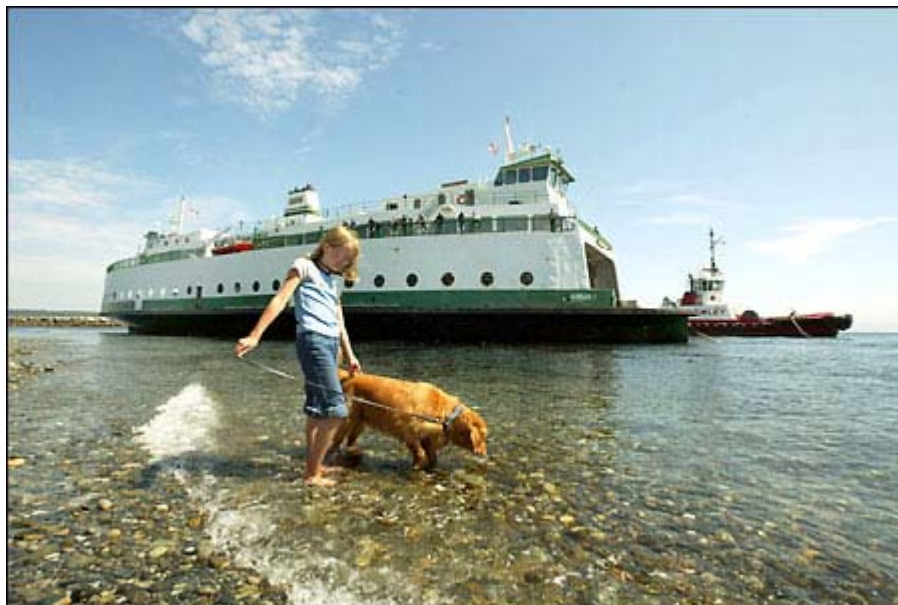
**Grounded State Ferry MV Quinault (source: Seattle Post-Intelligencer, August 23, 2002; photo credit: Meryl Schenker)**

- Crosscurrents are the greatest challenge in landing a ferry at Keystone. Because of the several groundings at the entrance to the harbor over the years (see photo), WSF has a set policy that ferries may not enter the harbor when crosscurrents exceed 3.5 knots, as determined at the nearest monitoring station. (Page 6)

- The typical approach at other ferry terminals in the WSF system would have the vessel beginning to back down at 1/4 mile (1,320 feet) from the wing walls, or about 1,100 feet from the outer dolphin. This is often not possible at Keystone because of the crosscurrents at the south end of the jetty. As the bow of the vessel crosses an imaginary east-west line at the south end of the jetty, the bow encounters slack water while the stern is being pushed strongly to the west by the current. To counteract the current force on the stern of the vessel, the captain must maintain propeller thrust on the rudder to steer. Often the current force exceeds the vessel's ability to compensate and this causes the vessel to veer from the preferred straight-in approach. The vessel captain must then correct course inside the south end of the breakwater prior to backing down for the final approach. The typical back down distance in Keystone is only 720 feet from the wing walls, or about 500 feet from the outer dolphin, which is less than half of typical. This condition is the cause of several groundings each year at Keystone Harbor. (Page 6)
